INDOOR AIR QUALITY REASSESSMENT

**Underwood Elementary School
101 Vernon Street
Newton, Massachusetts**

Prepared by:
Massachusetts Department of Public Health
Bureau of Environmental Health Assessment
July 2003

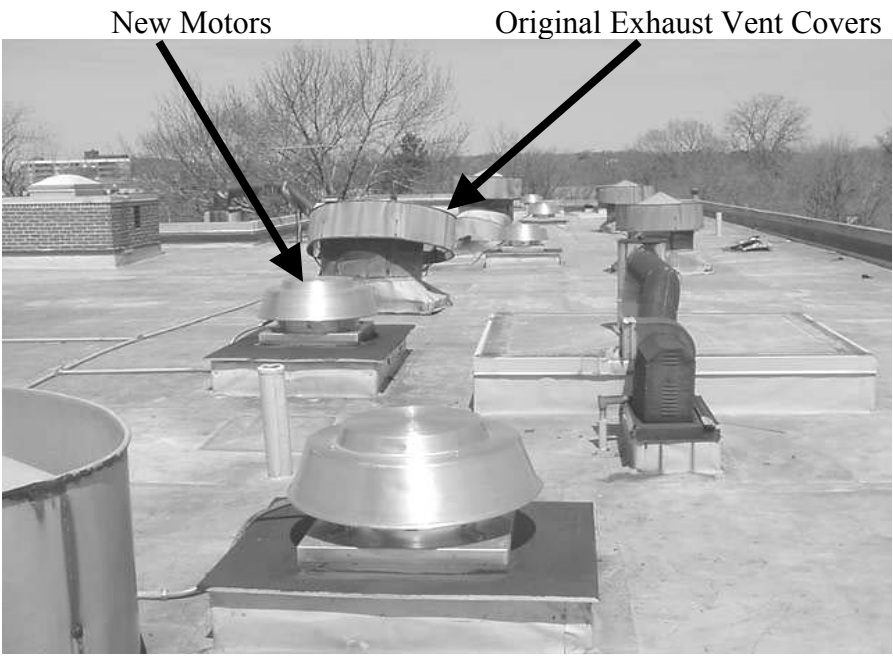
Picture 2

Exhaust ventilation is provided by a ducted system, with an exhaust grille mounted in the ceiling above the sink/countertop area of each classroom. It was reported by Mr. Deluca that these vents were originally designed as passive (non-motorized) exhaust vents that relied on the pressurization of classrooms to force air into the vents. A lack of pressurization (e.g. deactivation of univents, opening of classroom doors and windows) would prevent the removal of exhaust air from classrooms. Without proper exhaust ventilation, indoor air pollutants can build up and lead to indoor air quality/comfort complaints. The passive vents were replaced with modern mechanical rooftop exhaust vents (see Picture 2) several weeks prior to this BEHA reassessment. All exhaust vents were operating during the reassessment.

Newly Installed Exhaust Vent Motors, Note Original Passive Exhaust Vent Covers

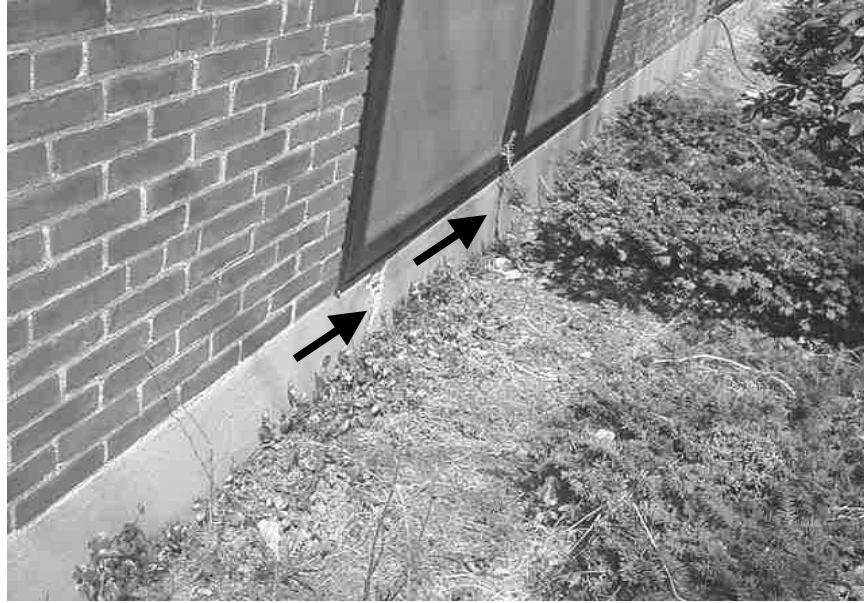
Picture 3

Classrooms in the basement located at the front of the UES had signs of water penetration through foundation walls. This was evidenced by the presence of peeling paint and efflorescence along exterior brick walls. Efflorescence is a characteristic sign of water damage to brick and mortar, but it is not mold growth. As moisture penetrates and works its way through mortar around brick, water-soluble compounds in bricks and mortar dissolve, creating a solution. As the solution moves to the surface of the brick or mortar, the water evaporates, leaving behind white, powdery mineral deposits. A coat of paint can serve as a water impermeable barrier, which can trap moisture. Brick, mortar and wall plaster are not good mold growth media, however water trapped behind wallpaper or paint coats can become mold growth media.

Shrubby and other plants exist in close proximity to the foundation walls (see Picture 3). The growth of roots against the exterior walls can bring moisture in contact with wall brick and eventually lead to cracks and/or fissures in the foundation below ground level (see Picture 3). Over time, this process can undermine the integrity of the building envelope and provide a means of water entry into the building through capillary action through foundation concrete and masonry (Lstiburek & Brennan, 2001).

Shrubbery and Other Plants Exist in Close Proximity to the Foundation Walls, Note Crack in Foundation

1. Due to the apparent configuration of the curtain wall/drainage plane system, measures should be taken to minimize water contact with the exterior walls. Removing trees outside of the kindergarten classrooms and foliage close to exterior walls is recommended.
2. If water penetration/efflorescence observed in various areas of the building returns, consideration should be given to having a building engineer examine each damaged area with the intent to recommend possible drainage plane remediation strategies.

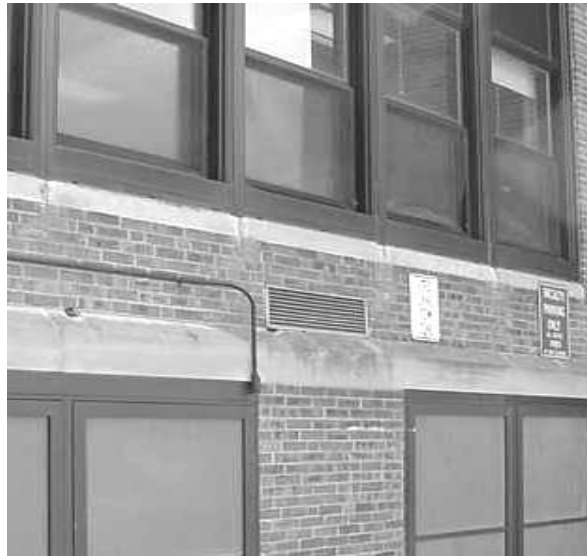
Picture 4

Of note is the configuration of the univent fresh air intakes (UFAIs). In most buildings assessed by BEHA staff, the exterior grills of the UFAIs are installed with the louvers parallel to

the ground (see Picture 4). These louvers are also usually beveled in a manner for rainwater to pour away from the univent opening, similar to a peaked roof on a house. The UFAI louvers at the UES are perpendicular to the ground (see Picture 5). This configuration can allow for driving rain to penetrate into the fresh air intake and accumulate in the floor of the univent instead of rolling off the louver and away from the univent. Moist weather tends to travel in a northeasterly track up the Atlantic Coast towards New England (Trewartha, 1943). Wet weather systems generally produce south/southwesterly winds, which can impact on westerly and southerly facing UFAIs. UFAIs are also prone to accumulating outdoor debris, dirt and other materials that can serve as mold growth media. With repeated water penetration, these accumulated materials can become moistened, resulting in potential mold growth, particularly within several days after rainstorms.

Typical Exterior Grills of the UFAs Installed with the Louvers Parallel to the Ground

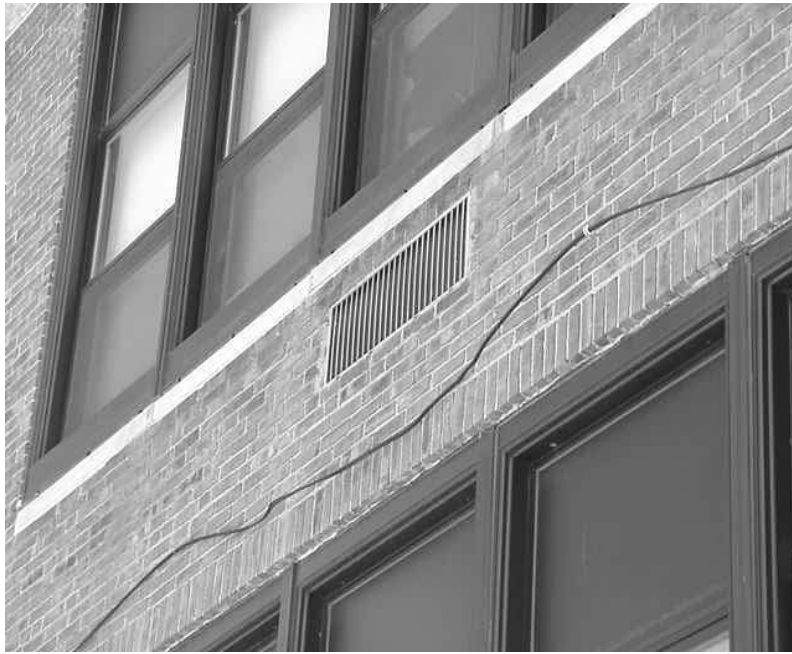
Picture 5

UFAs Louvers on the UES Installed Perpendicular to the Ground

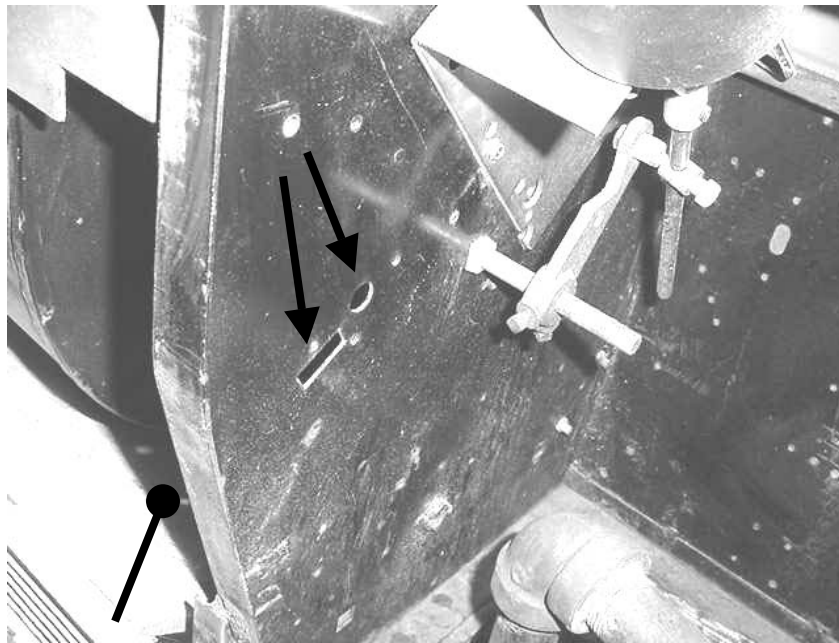
Picture 6

Several of the interiors of univents were randomly evaluated. Spaces and holes within the air handling cabinet of univents were observed (see Pictures 6 and 7). Dust around the edges of each hole indicates that unfiltered air enters the air handling cabinet. The existence of these holes allows for air to by-pass filters, resulting in aerosolization of materials (e.g. dust) into the classroom. In addition, spaces exist around heating pipes that penetrate through the floor. Spaces of this nature can result in the univent drawing air and debris from the wall cavities or crawl spaces and distributing these materials to the interior of the building.

Filter
Holes Post-Filter in Wall of Air Handling Chamber of Univent

1. Ensure univents and exhaust vents are free of obstruction.
2. Seal all holes in the walls of the univent air handling cabinets to limit filter bypass.
3. Seal wall and pipe floor holes within univent casing.
4. To maximize air exchange, the BEHA recommends that both supply and exhaust ventilation operate continuously during periods of school occupancy independent of classroom thermostat control.
5. Repair the fresh air intake louver for classroom 5 univent.
6. For buildings in New England, periods of low relative humidity during the winter are often unavoidable. Therefore, scrupulous cleaning practices should be adopted to minimize common indoor air contaminants whose irritant effects can be enhanced when the relative

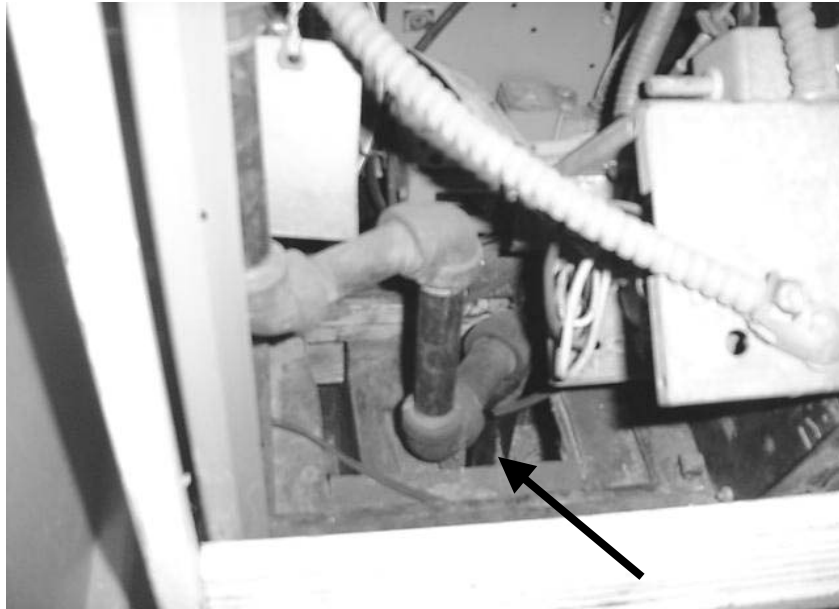
Picture 7

Hole in Floor of Univent

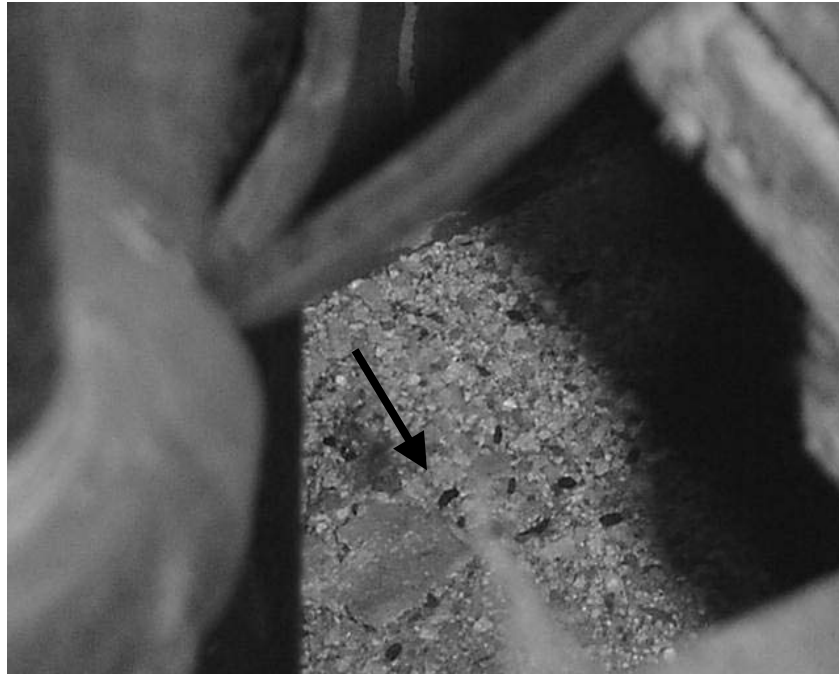
Picture 8

Of note was the heavy accumulation of mouse droppings inside the wall cavity, which was found open to the univent cabinet (see Picture 8). Classrooms contained a number of conditions that may attract rodents. Stored food containers were noted in some classrooms. In addition, one classroom and hallway (see Picture 9) had student art projects that were made with food. Each of these circumstances can create conditions that attract pests. Under current Massachusetts law (effective November 1, 2001) the principles of integrated pest management (IPM) must be used to remove pests in state buildings (Mass Act, 2000). Pesticide use indoors can introduce chemicals into the indoor environment that can be sources of eye, nose and throat irritation. The reduction/elimination of pathways/food sources that are attracting these insects should be the first step taken to prevent or eliminate this infestation.

Rodent infestation can result in indoor air quality related symptoms due to materials in their wastes. Mouse urine is known to contain a protein that is a known sensitizer (US EPA, 1992). A sensitizer is a material that can produce symptoms in exposed individuals can cause running nose or skin rashes in sensitive individuals (e.g., running nose or skin rashes). A three-step approach is necessary to eliminate rodent infestation:

Mouse Droppings in Wall/Floor Cavity below Univent

1. Removal of the rodents;
2. Cleaning of waste products from the interior of the building; and
3. Reduction/elimination of pathways/food sources that are attracting rodents.

To eliminate exposure to allergens, rodents must be removed from the building. Please note that removal, even after cleaning, may not provide immediate relief since allergens can exist in the interior for several months after rodents are eliminated (Burge, 1995). A combination of cleaning,, along with an increase in ventilation and filtration should serve to reduce rodent associated allergens once the infestation is eliminated.

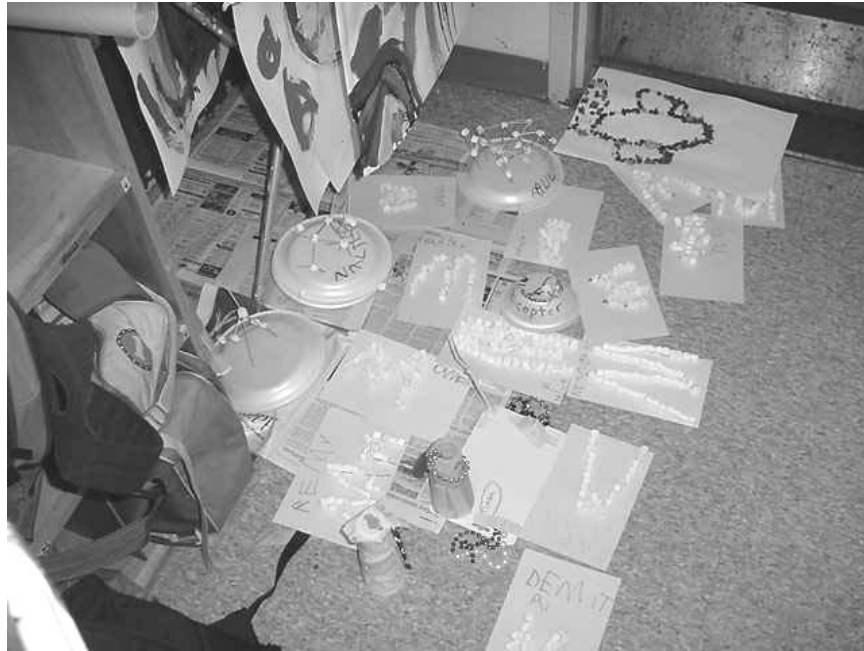
Picture 9

Student Art Projects That Were Made With Food

- a) Do not use food as components in student artwork.
- b) Rinse out recycled food containers. Seal recycled containers in a tight fitting lid to prevent rodent access.
- c) Remove non-food items that rodents are consuming.
- d) Store foods in tight fitting containers.
- e) Avoid eating at workstations. In areas where food is consumed, periodic vacuuming to remove crumbs are recommended.
- f) Regularly clean crumbs and other food residues from ovens, toasters, toaster ovens, microwave ovens coffee pots and other food preparation equipment;

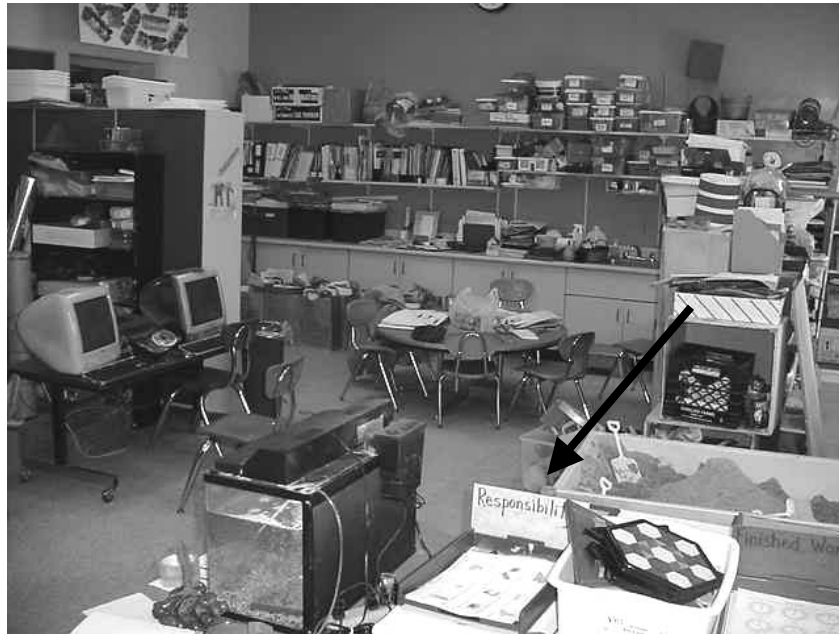
Picture 10

Sandbox in Classroom
